CARIBBEAN CEMENT COMPANY
KINGSTON, JAMAICA WEST INDIES

JULY 1982

UNDERWATER FACILITIES
INSPECTIONS
AND
ASSESSMENTS
AT

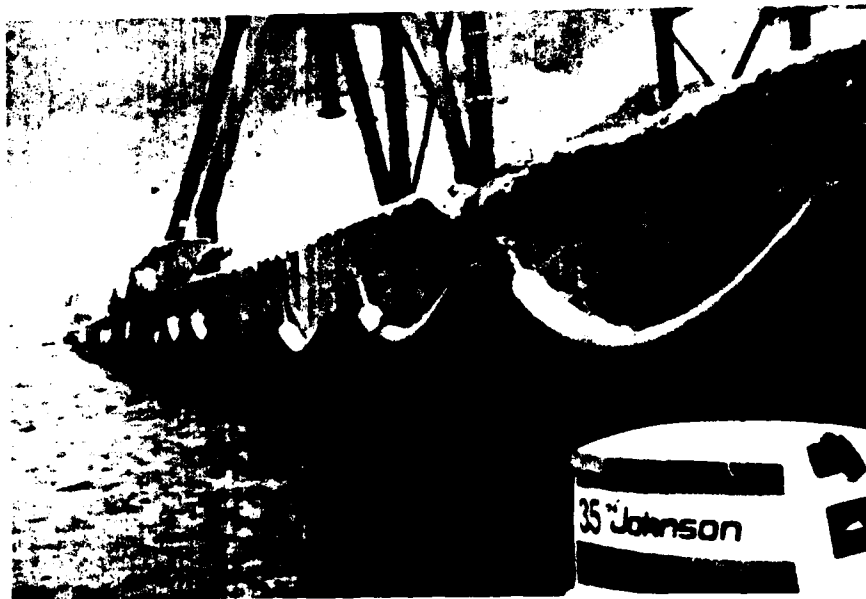
PHOTO #21: Outboard face of the wharf which corresponds to Bent L
